LAPORAN PENELITIAN

“Metallurgical Analysis of Fatigue Failure in Submerge Chain Conveyor”

**INSTITUT TEKNOLOGI NASIONAL
BANDUNG - 2020**

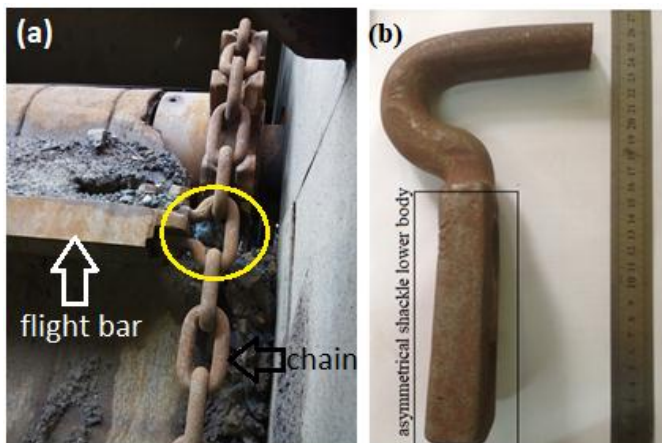
Fig 1. The shackle chain when in use as indicated by yellow circle (a) and the failed shackle chain (b).

It can be seen in Fig 1a, the shackle chain is connected to the chains and flight bar while in Fig 1b, the failed shackle chain was corroded indicated by light brown referring to iron oxides and it was torn into two sections. This failed component was taken for further investigation. The type of shackle chain used was padless shackle connectors with double bolt chain connecting shackles and the terminology used in this paper is briefly shown in Fig 2.

The evidence showing the increase of gap (clearance) between the upper and lower body in connection systems had occurred was clearly shown in Fig.1b in which the lower body was not symmetrical. Thus the failure of the shackle chain was preceded by the occurrence of pitting corrosion on the outer surface of the crown area and the dynamic load due to clearance which occurred in the bolt and nut system causing propagation of cracks and finally the fracture occurred.

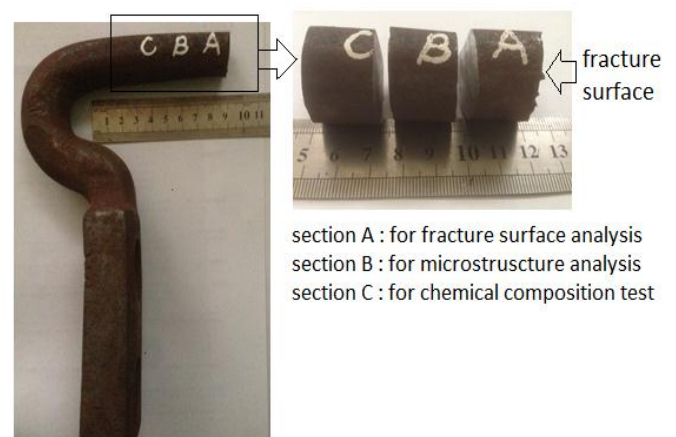
Fig.3 Three samples with each letter A, B and C, taken from the broken shackle chain for investigation

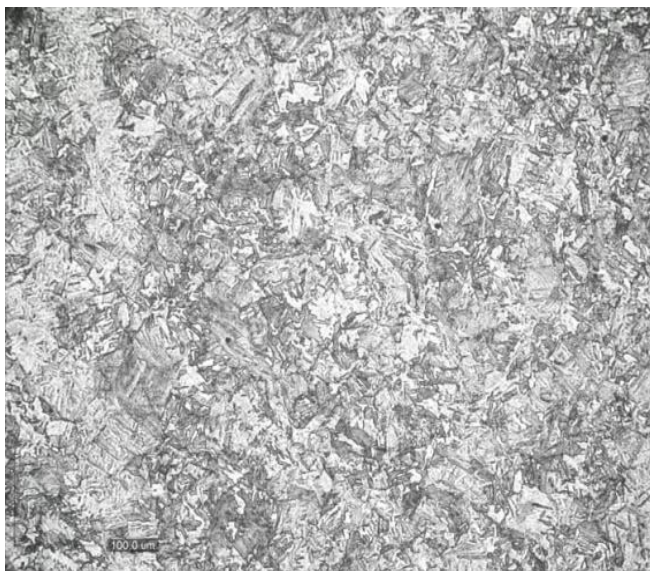
The microstructure of the broken shackle chain (Fig. 4) consisted of ferrite, and tempered martensite, and indicated that the shackle chain had experienced heat treatment process. The AISI 4140 steel usually had a high hardenability, strength, and wear resistance. The elements of Cr and Mo are generally known as carbide formers as well as ferrite stabilizers, while Si tends to improve high temperature wear resistance of the steel [9, 10].

Fig. 4 Microstructure of the broken shackle chain.

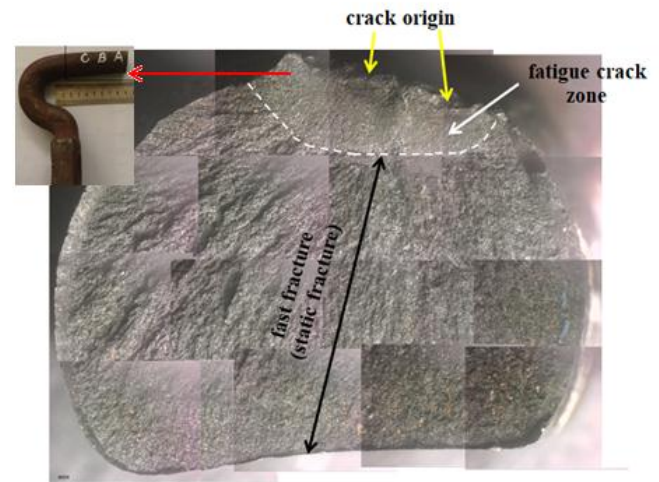
Fig.5 Optical image of a fracture surface collage made by superposition of specific areas and the white dashed line indicate the distinct fracture zones (the insert picture in the top left corner indicated by red arrow is the location of the crack origin of sample A in Fig 3.).

Fig. 5 showed the information of the location of crack origin, and the fracture surface morphology. Two locations of initial crack were observed and beach marks showing fatigue crack propagation were seen in the crown region close to the surface outer. There was a clear distinction between smooth fatigue zone and final overload. The fatigue zone was smaller than the static fracture zone.

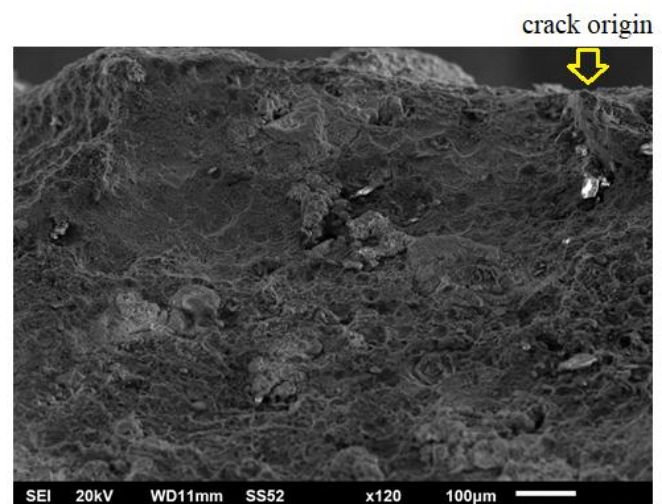
Fig.6 Secondary electron image on fatigue crack zone showing a fairly flat surface with beachmarks and crack of origin.

SEM observation shown in Fig. 6 indicated that the fracture surface was smooth and the location of crack origins was close to outer surface of the crown area of the shackle chain. Fatigue cracks remained fairly flat in appearance even, but they had a shape similar to 'cottage cheese' which was slightly rippled [11].

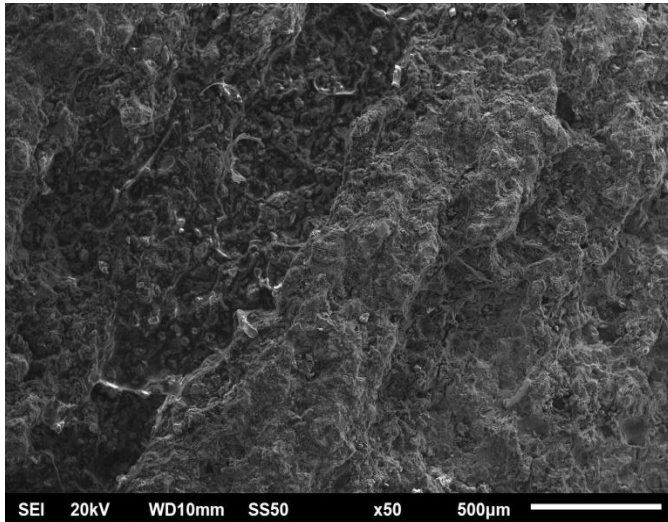
Fig. 7 Secondary electron image on the static fracture zone.

Fig 7 showed SEM image on static propagation with brittle fracture characteristic, which was indicated by transgranular crack. The small fatigue zone and the transgranular mode in static area exhibited that the material of shackle chain was brittle.

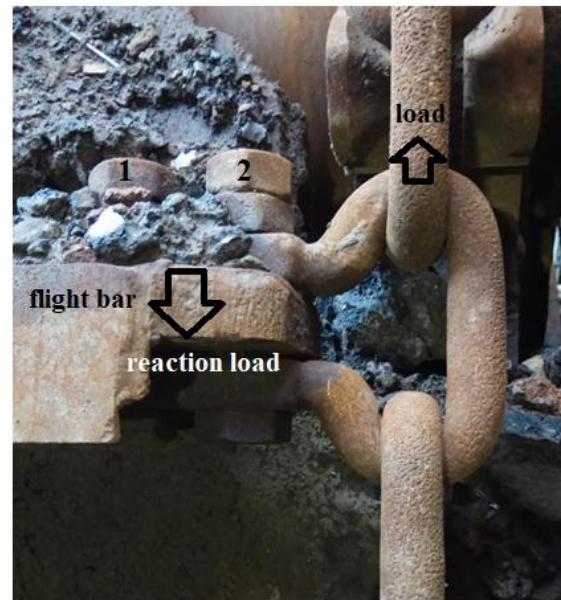
Fig. 8 Load and reaction load which occurred when shackle chain was in use and the shackle chain was locked down to the flight bar by two bolts (number 1 and 2).

Fig.8 showed the load and reaction load during the shackle chain was operated. The shackle chain at the bow (chain link) was connected to the chain and at the upper / lower body was connected with a "locked" flight bar using a configuration of 2 pairs of bolt and nut (marked with "1" and "2" in Fig.8).

In a normal condition, the connection system (bolt and nut) that integrated the shackle chain with the flight bar must be tight and the load carried by the flight bar would be fully restrained by the chain link (load reaction). We expected no dynamic load acting on the shackle chain. On the other hand, if the connection system (bolt and nut) did not work well, for example due to wear or corrosion, it would cause an increase in the gap (clearance) in the connection system (bolt 1 and 2). This caused a relative force between the upper shackle body and the lower shackle body resulting in the moment on the crown so that the load reaction was not fully held by the chain link / bow.
