LAPORAN PENELITIAN

“Metallurgical Analysis of Fatigue Failure in Submerge Chain Conveyor”

**INSTITUT TEKNOLOGI NASIONAL
BANDUNG - 2020**

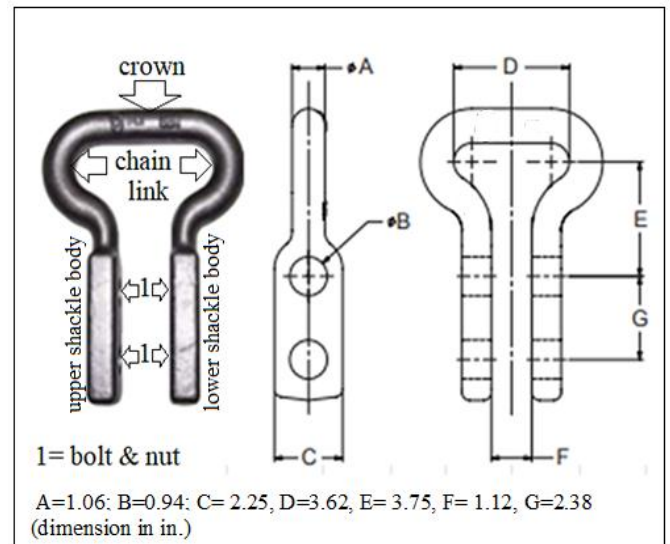
Fig. 2 Padless shackle connectors with double bolt chain connecting shackles and terminology of the shackle chain used in this paper.
